NASA Contractor Report 166015

Advanced Manufacturing Development of a Composite Empennage Component for L-1011 Aircraft

**PHASE V — FINAL REPORT
FULL SCALE GROUND TEST**

**LOCKHEED-CALIFORNIA COMPANY
BURBANK, CALIFORNIA**

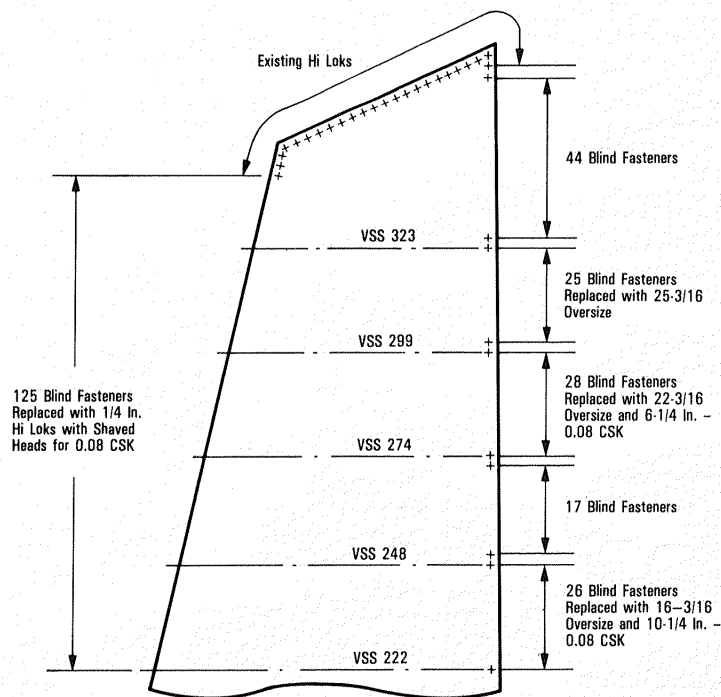
Figure 30. - Fastener replacement.

The test loading was next increased to 80 percent DUL at which point loud popping and cracking sounds were heard. The load was reduced and a visual inspection performed. It was found that some blind fasteners (MS 21140-06) in the left hand front spar cap-to-cover joint had tipped. The use of blind fasteners is restricted by the fin assembly drawing to the left hand cover-to-solid web rib cap connection. These ribs prevent the necessary access to install the HL 13 pins and HL 94LP collars. The reason for installation of blind fasteners in the upper portions of the front and rear spar cap-to-cover connection from VS 222 on the left hand side was stated on a discrepancy report to be mechanic error. No corrective action was taken

to remove these fasteners as their strength was judged to be sufficient to provide a positive margin in this location. The blind fasteners in the front spar and 78 of the more highly loaded blind fasteners in the rear spar were removed and replaced with 1/4 inch or 3/16 oversize Hi-Loks. The 1/4 inch fasteners were installed in holes which had been damaged by the tipping and could not be cleaned up at the 3/16 oversize. The heads on the 1/4 inch Hi-Loks were shaved for 0.08 countersink depth, the same as the 3/16 inch diameter. Figure 30 shows the areas where the fasteners were replaced.

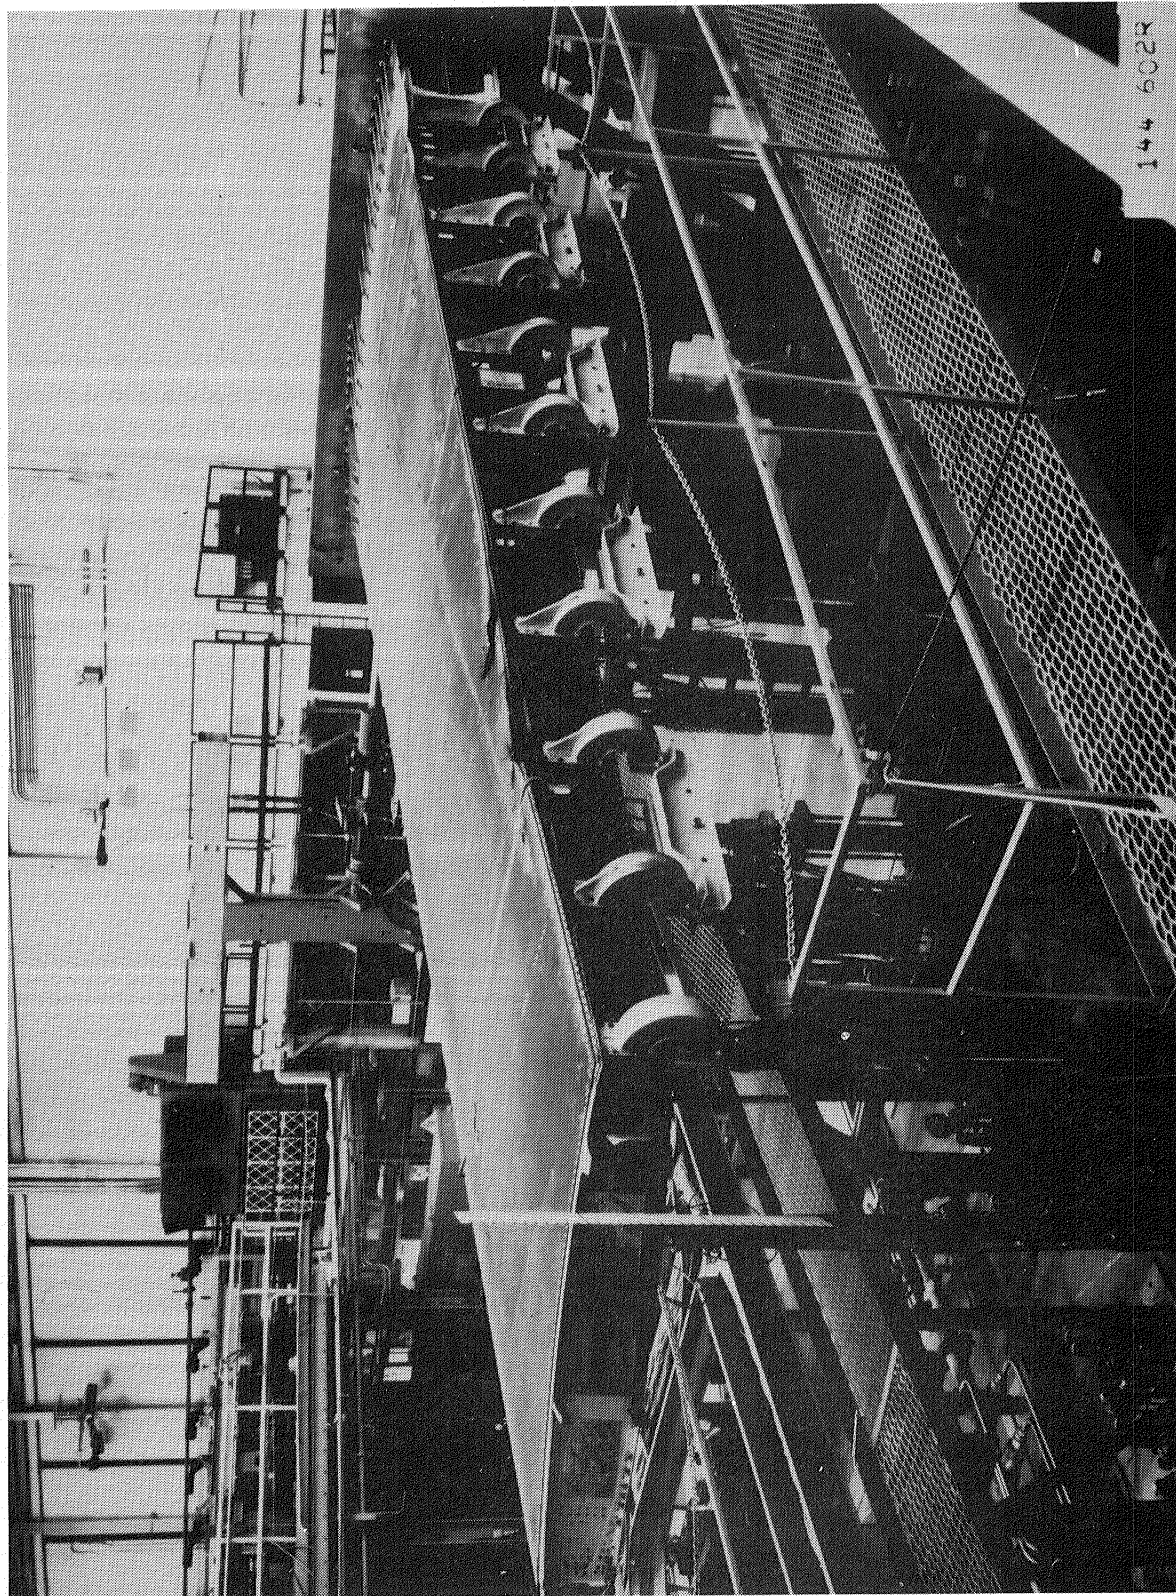
Figure 31. - Test component after failure.

3.1.2 Failure Investigation.--The failure resulted in damage to the front spar left hand cap from root to tip, local left hand cover damage including separation of the skin and stiffener in the runout bays toward the tip, separation of rib to front spar web attach members at all rib stations, and left hand rib cap damage on most of the truss ribs along the line of a skin buckle between cover stiffeners eight and nine. The left hand cover was the tension surface in this test.

The failed fin box is shown in figure 31 and figure 32 shows the locations of the failures. Examination of movie film taken during the test indicated that failure initiated in the front spar cap between VSS 299.97 and VSS 323.62. Six frames of the movie film are shown on Figure 33 and indicate the failure sequence. These frames were computer enhanced by J.P.L. to improve their clarity. Figures 34 and 35 show the primary failure zone.

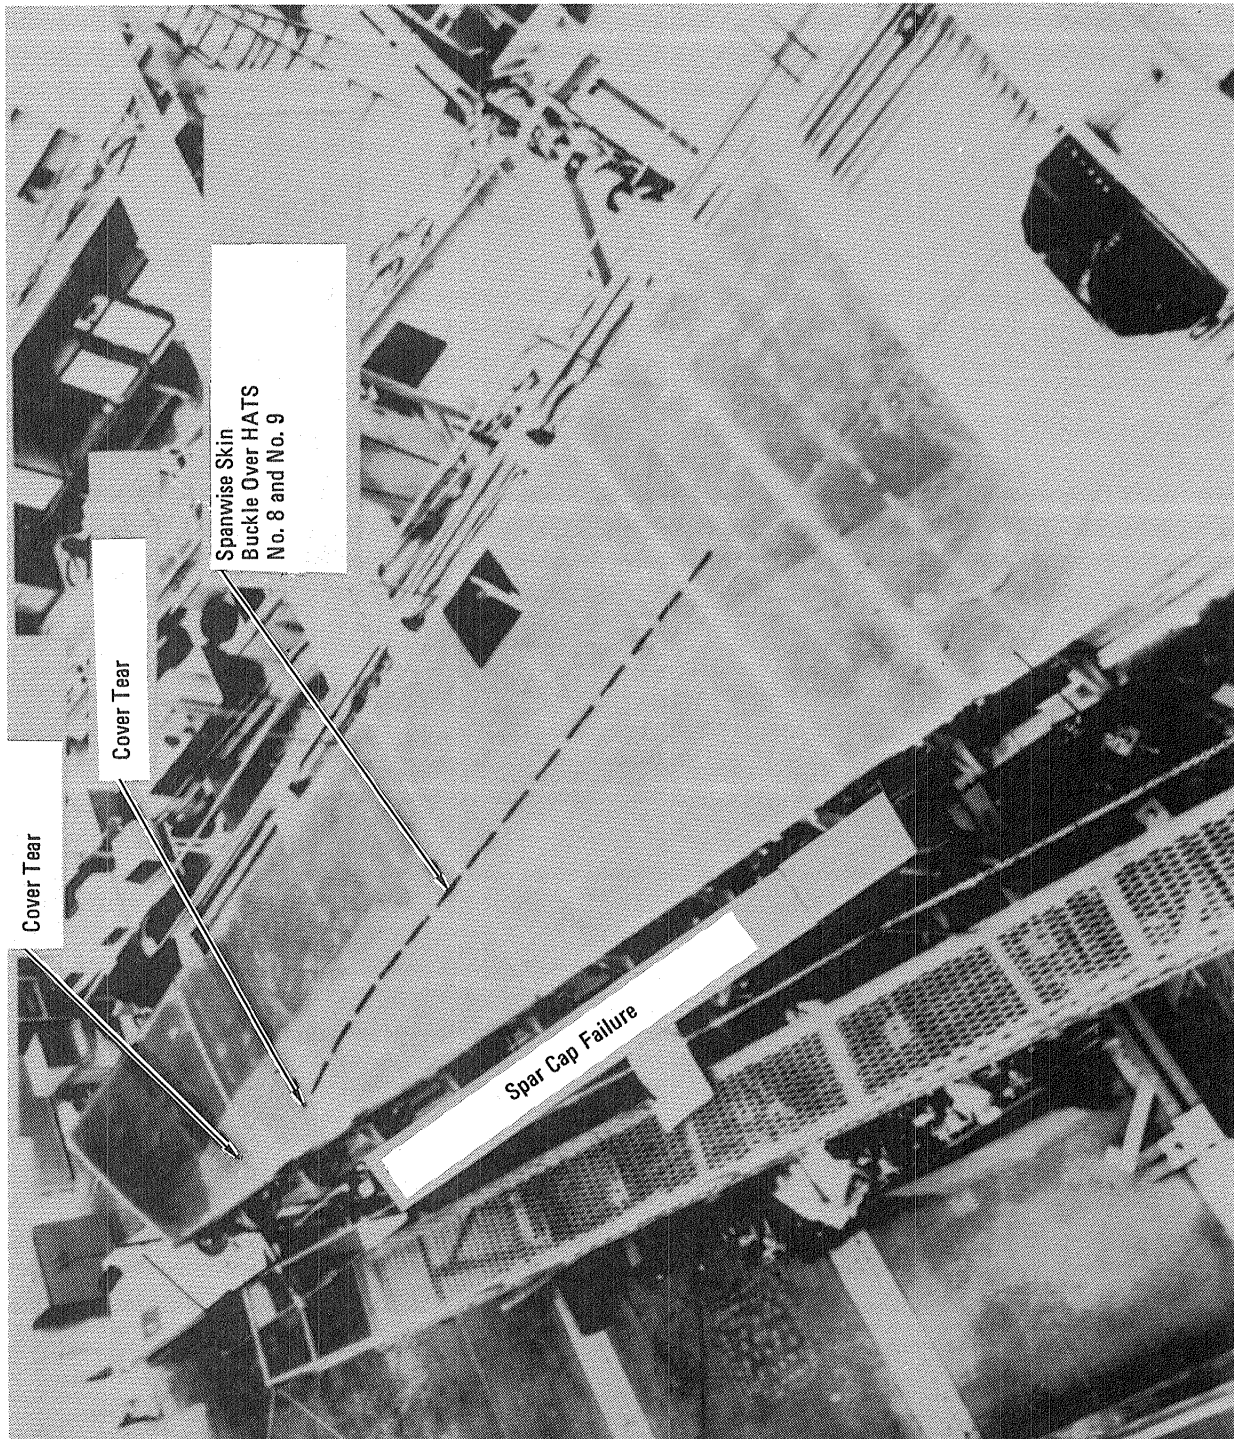
Figure 32. - Overall view of failure.

The failure sequence has been identified as follows: The spar cap failed first in interlamina tension between VSS 299.97 and VSS 323.62. The failure then progressed along the spar to tip and then to the root. The initial failure and subsequent progression along the spar caused an increase in axial load in the free edge of the cover and high torsional deflections resulting in tearing of the cover at solid rib stations VS 299.97 and VSS 274.25, buckling of the skin and disbonding of hat stiffeners near the front spar. Figure 34 shows the skin tear at VSS 299.97. Due to the open box section the shear center shifted aft behind the rear spar and caused a large increase in the compression load in the left hand truss rib caps resulting in progressive failure of the rib caps down to and including VSS 145.71. Figure 36 shows the rib cap failure at VSS 248.55. This is typical of the rib cap failures. The rotation of the spar cap about the right hand surface (lower surface in test set-up) caused failure of the rib connection to the spar.

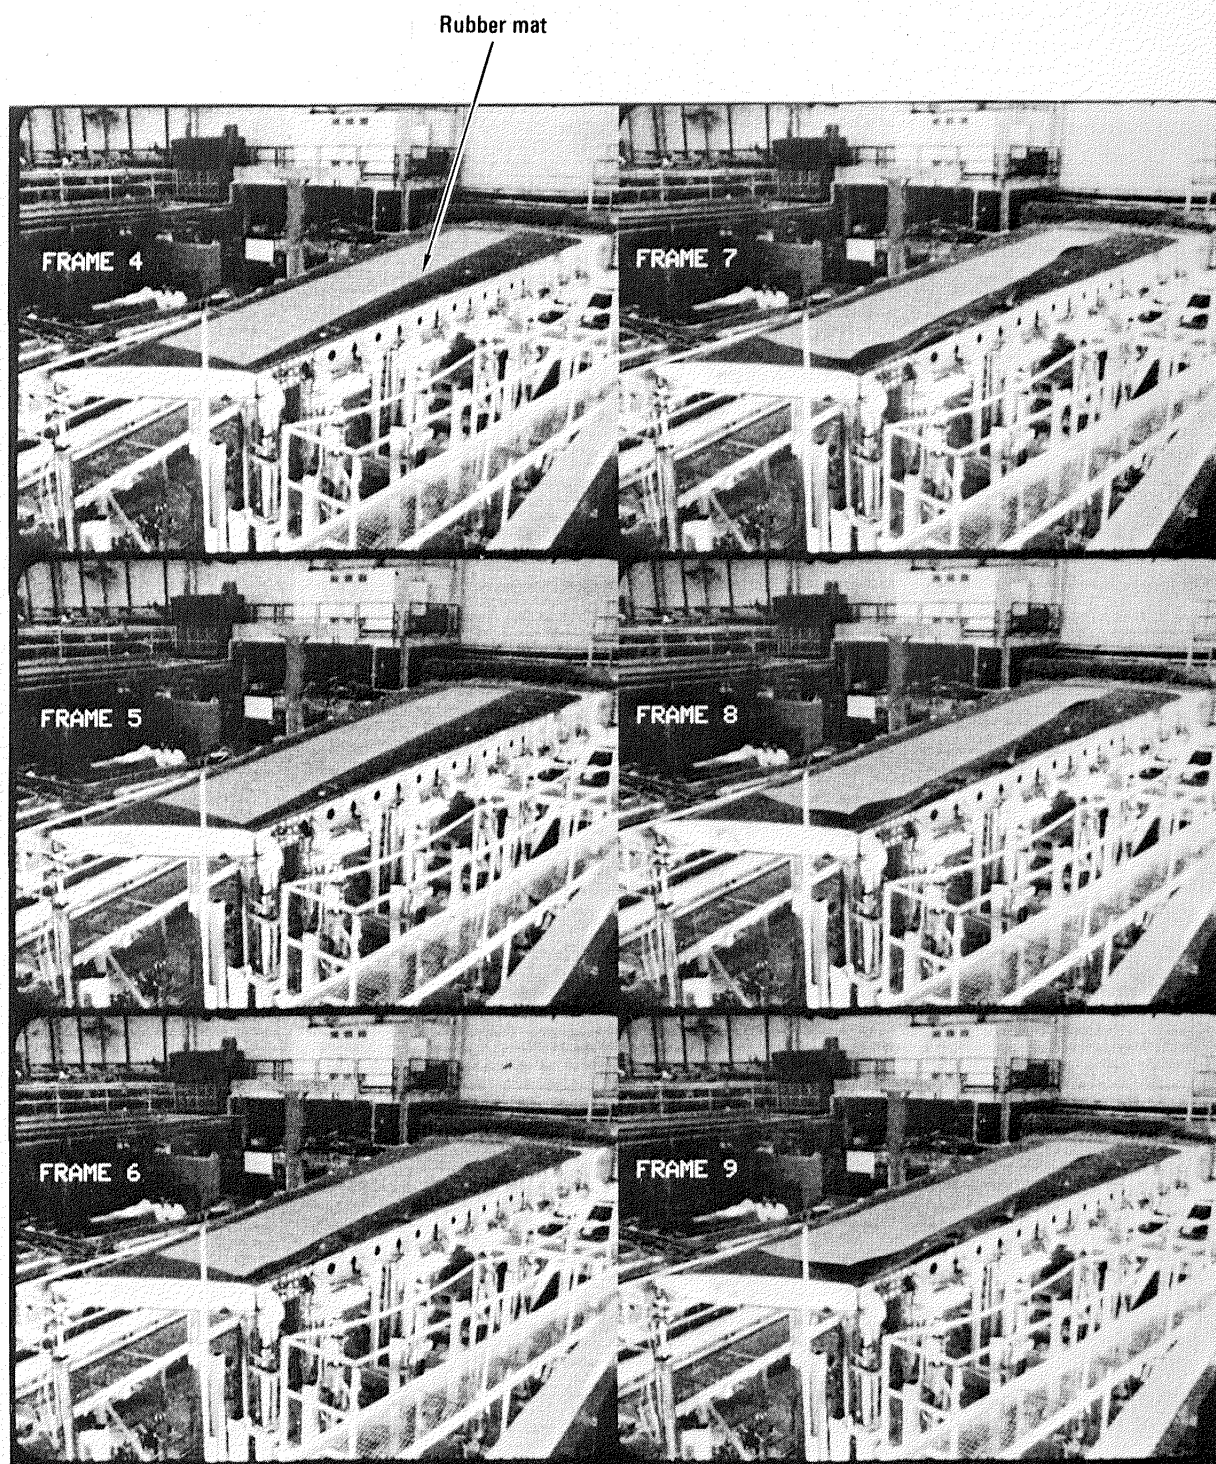
Figure 33. - Six frames from high speed movie showing failure sequence.

The rubber mat laying on top of the test article shows a dynamic response to the fin failure. The wave mode bears no direct relationship to the failure mode.

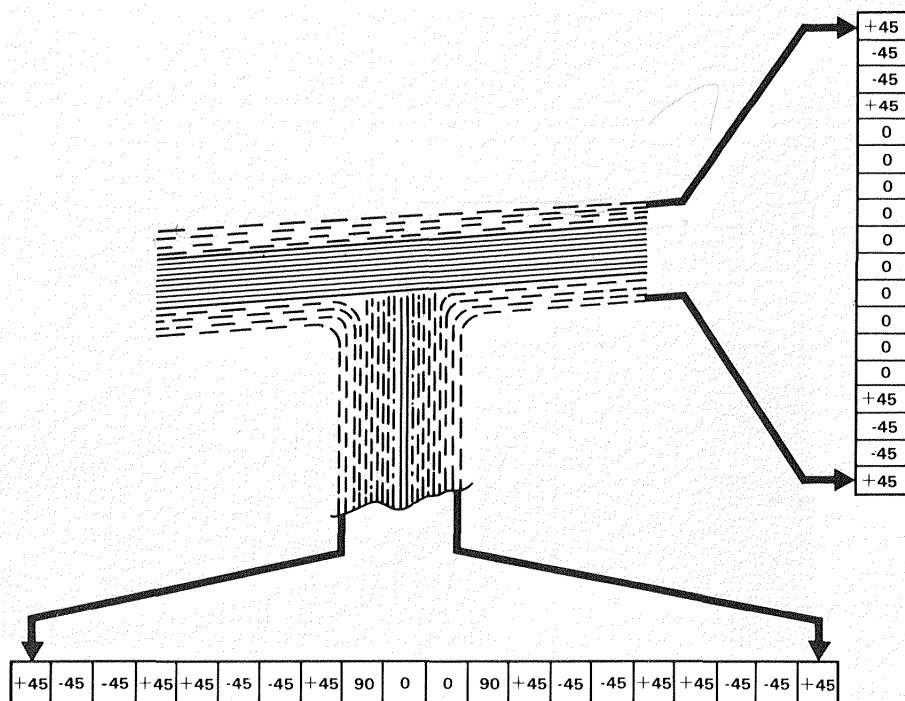
Figure 37. - Front spar cap configuration in primary failure zone.

A review of the design details uncovered a deficiency in the spar design. The front spar cap and web-to-cap configuration in the area of the primary failure is shown in Figure 37. This portion of the cap consists of four plies of $+45^\circ$ or -45° orientation, then ten plies of 0° orientation, and four more $+45^\circ$ or -45° plies. The four plies from each side of the spar web are continued around to become part of the spar cap. The remaining twelve plies terminate at the cap. A photomicrograph (Figure 38) of a section of the right hand spar cap, with a similar configuration to the left hand cap in the primary failure zone, shows that failure has initiated in this location. The four plies of web material are separated from 0° cap material through the radius and into the flange. A crack extends across the web. A microcrack is also visible in the spar cap. By contrast Figure 39 shows a photomicrograph of a comparable section taken from an untested spar cap. No cracks are visible in this section.

While the test specimens failure modes were not identical to the GTA failure mode they were similar enough to conclude that the GTA failure mode was due to a combination of loads which applied interlamina tension and bending to the spar cap. The tests showed that the spar cap had very low strength capability in interlamina tension and that a low cycle high load fatigue spectrum could cause a significant drop in strength.

The configuration of the spar cap in the region where the failure initiated is shown in Figure 37. In order to provide more strength for

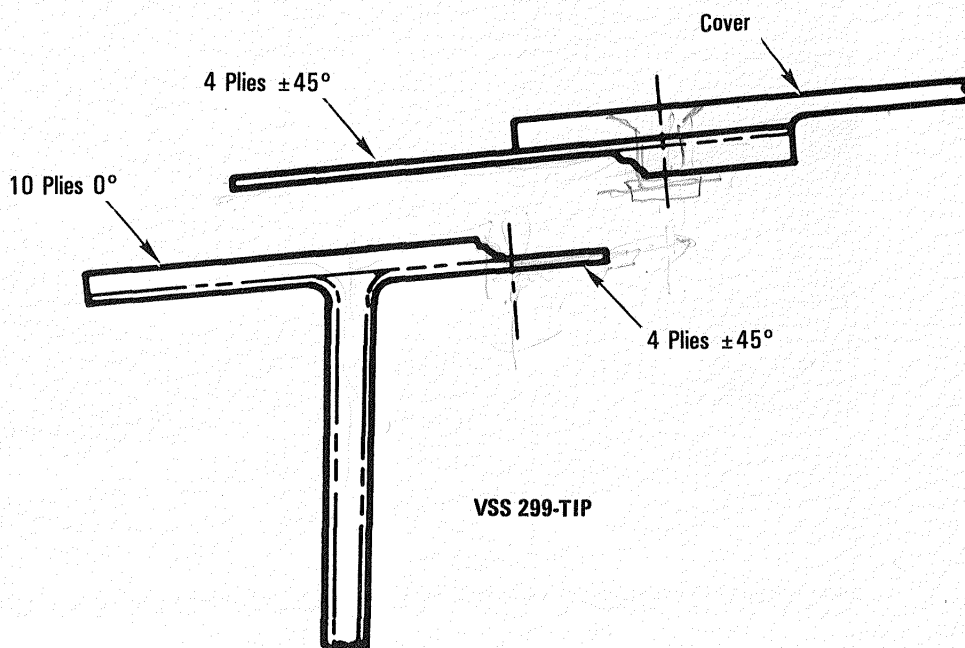
Figure 40. - Diagrammatic view of primary failure.

The damage in the primary failure zone is shown pictorially in Figure 40. Failure consisted of separation of the $\pm 45^\circ$ plies from the 0° plies with the failure propagating from one interface to the other through the 0° plies. The failure was caused by out-of-plane loads which inflicted interlamina tension and bending on the spar caps. These loads come from several sources. Transverse cover loads are due primarily to Poissons effects and are offset from the spar cap mid plane, thus introducing bending. Shear buckling of the trapezoidal panels adjacent to the front spar cap (see Figure 41) introduce both bending and normal loads to the spar cap plus diagonal tension loads. A load will also occur from the spars pulling down the upper cover to conform with the deflected shape. The cover curvature due to airfoil camber also introduces a normal component of load. Some of the loads are additive and some subtract and the net effects will vary with location.

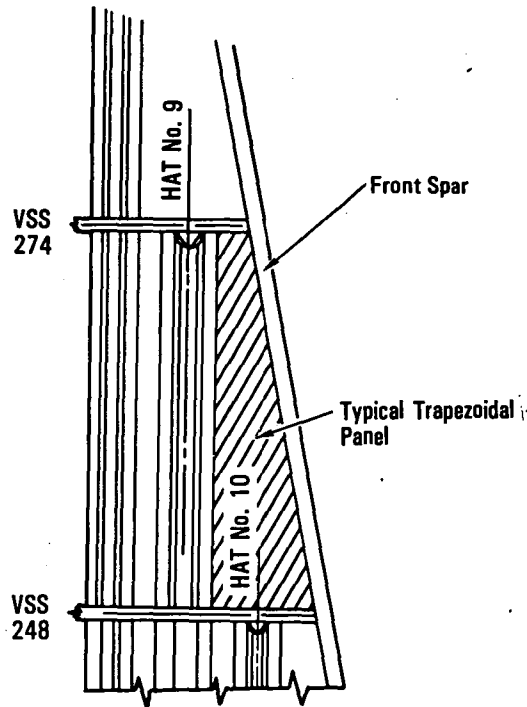
Figure 41. - Location of typical skin trapezoidal panel.

The trapezoidal skin panels adjacent to the front spar in the 10-ply skin area above VSS 248 buckle in shear below limit load. A typical panel is shown in Figure 41. During the failure sequence on GTA No. 1 the stiffeners adjacent to the front spar debonded primarily along the forward flanges in the 10-ply area. The skin was too thin to countersink for fasteners to preclude the debonding of the skin and stiffener in the run-out bays. For the test article 0.032 aluminum doublers were bonded and mechanically attached to both covers locally as shown in Figure 49. These doublers were dimpled at the front spar cap to fit the existing countersinks. The doublers also were countersunk, for the 5/32 inches diameter HL11 fasteners installed along the stiffener flanges.

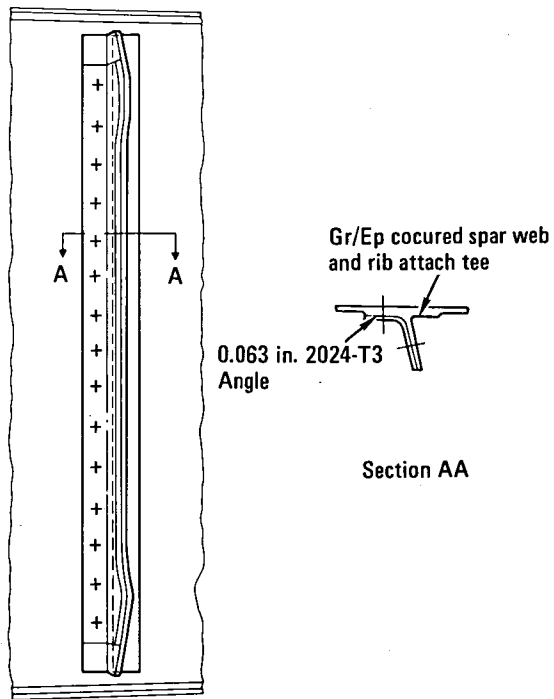
Figure 48. - Front spar to rib attachment reinforcement.

The ribs are attached to the front spar web through a cocured graphite/epoxy tee. At the rear spar the ribs are attached through aluminum angles which are located and mechanically attached on assembly. A secondary failure on GTA No. 1 involved the separation of the cocured graphite/epoxy tee on the front spar. These tees were reinforced with aluminum angles as shown in Figure 48. The angles are 0.063 in. thick 2024-T3 mechanically attached to the web.

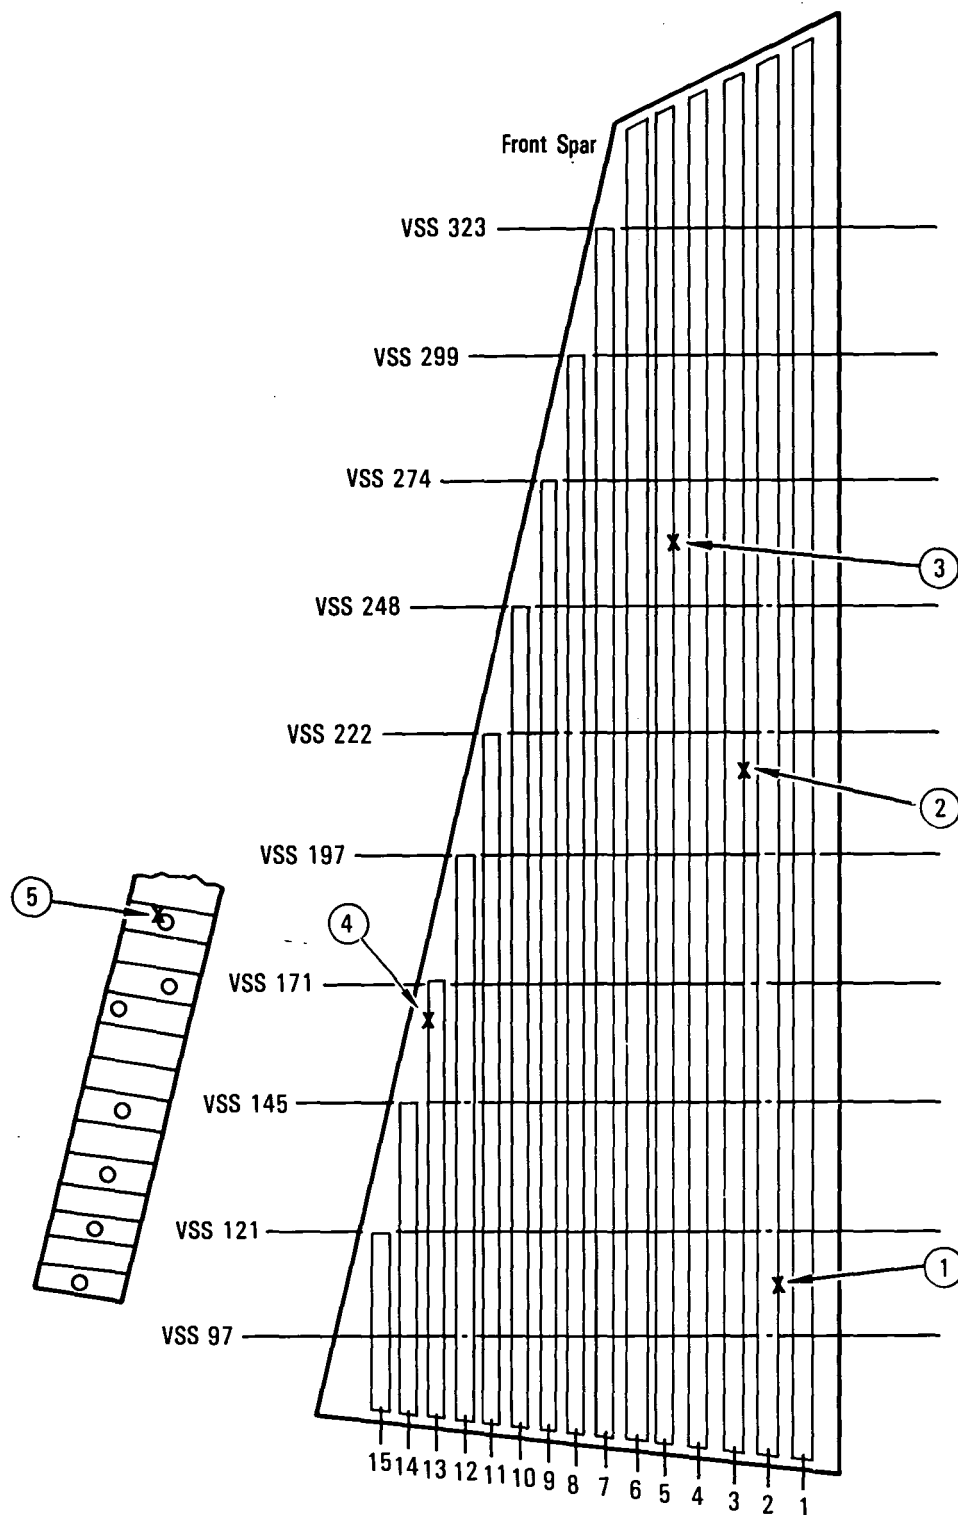
Figure 52. - Impact damage locations.

Impact No. 2 was in the 14-ply skin area. Four impacts were required to obtain visible damage. The first impact was a 13.33 ft.-lb. Some damage was evident ultrasonically. A second impact at 8.64 ft.-lb. showed no evidence of change ultrasonically. A third impact, now back at 13.33 ft.-lb. gave no visible damage but increased the damage area determined ultrasonically. A fourth impact was made, but at an energy level of 18.95 ft.-lb. Visible penetration through the thickness occurred.

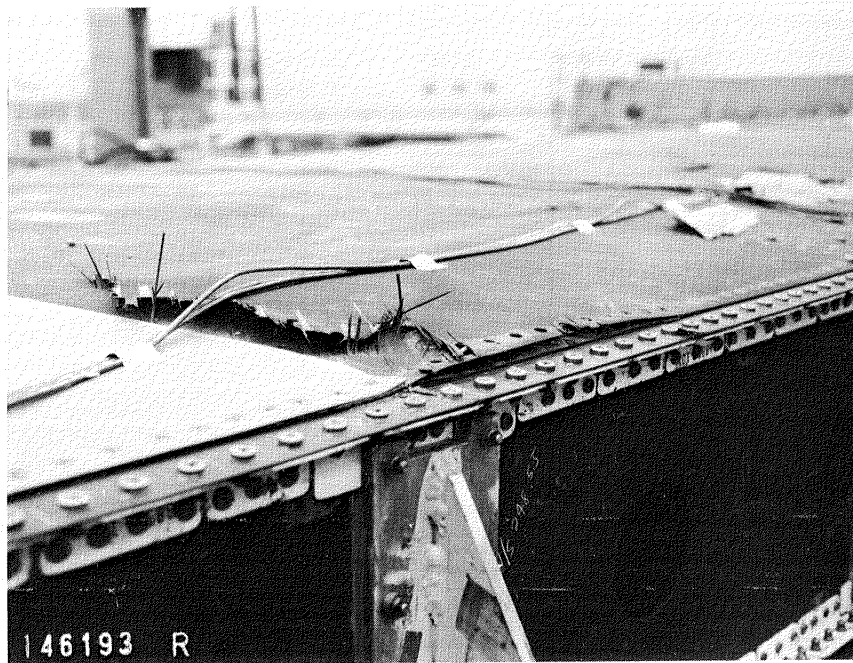
Figure 67. - Cover failure in vicinity of VSS 248.

The initial failure was caused by high interlaminar tension stresses induced by shear buckling of the skin panel between VSS 248 and VSS 222 and between the front spar and stiffener No. 10. Buckling initiated about design
